Preliminary Results of Post-Disaster Archaeological Investigations at the Char Narayan Temple and within Patan's Durbar Square, Kathmandu Valley UNESCO World Heritage Property (Nepal)

Coningham, R.A.E.¹, Acharya, K.P.², Davis, C.E.¹, Kunwar, R.B.³, Tremblay, J.C.¹, Simpson, I.A.⁴ and Schmidt, A.¹

2. Earthquake Damaged Monuments in Patan's Durbar Square

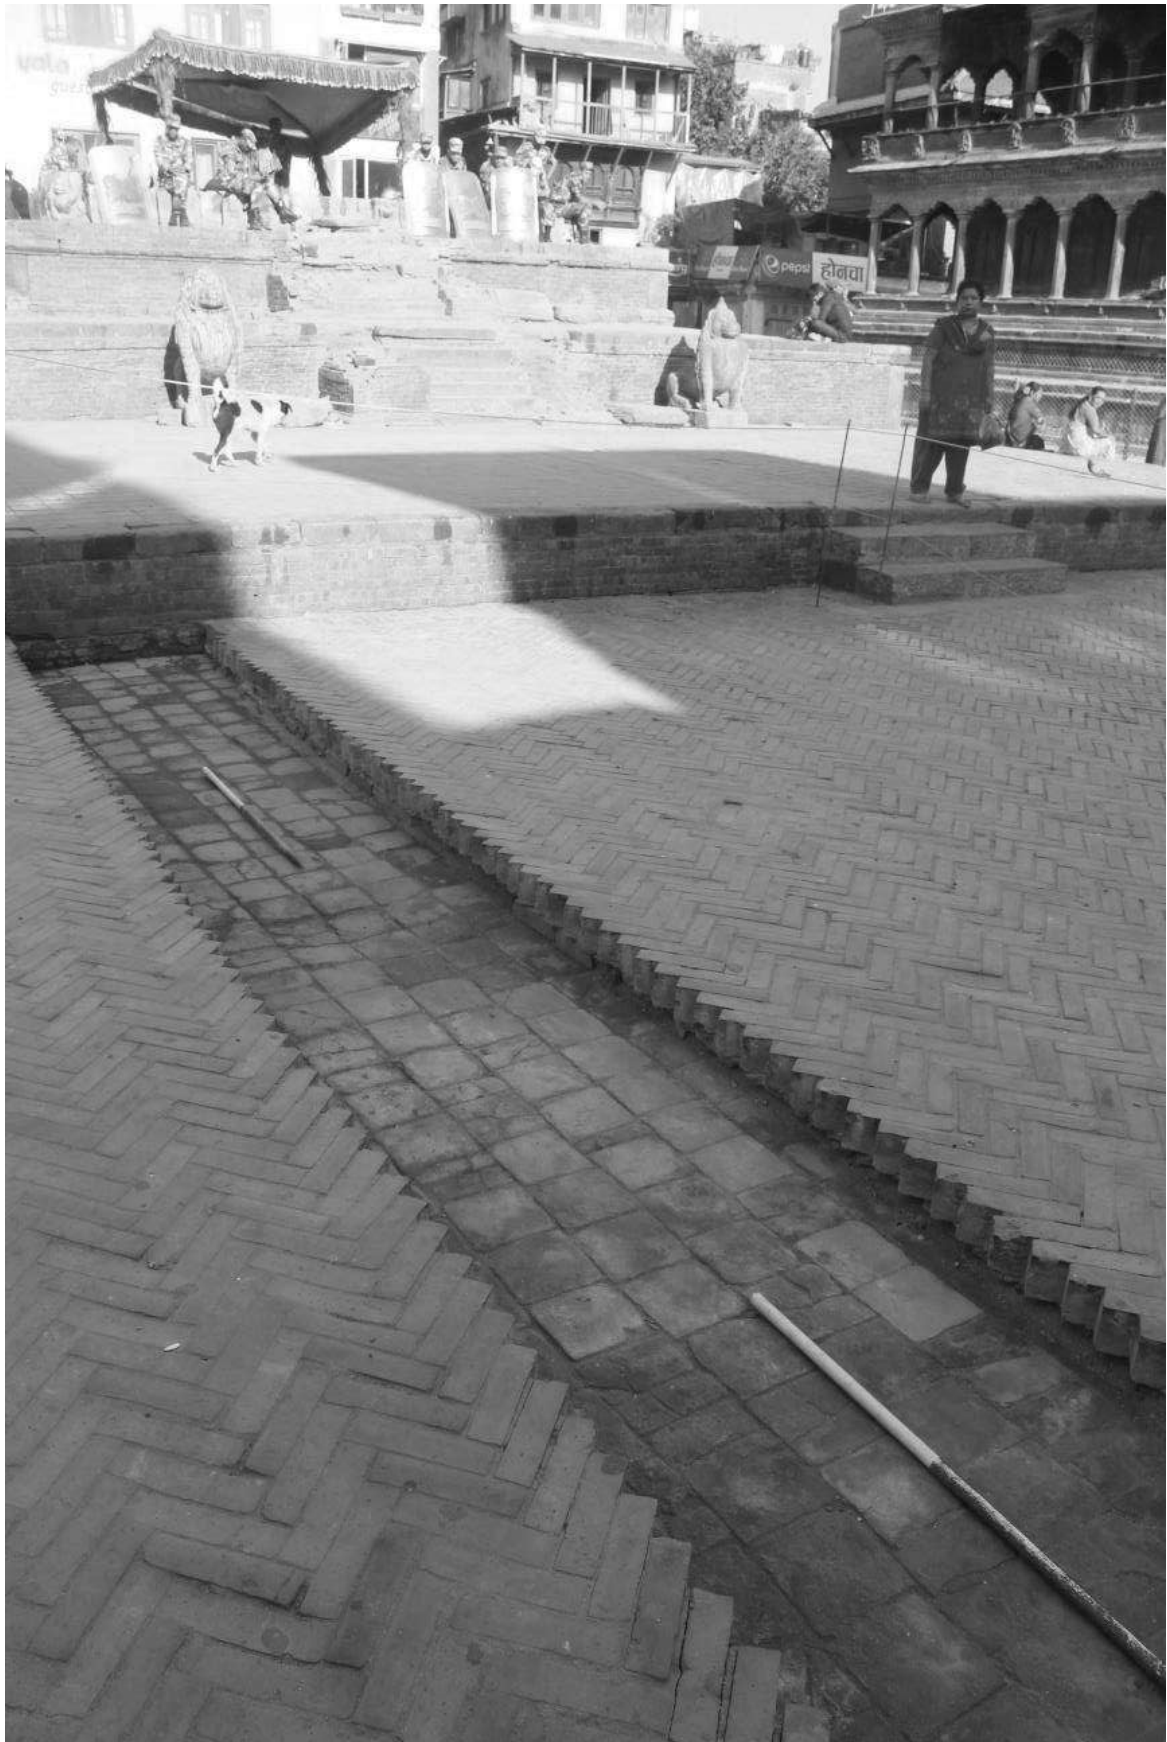
Representing an earlier surface over the Durbar Square, this pavement was formed by a single regular course of square tiles that individually measured 0.18 by 0.18 by 0.045 metres (Figure 4). This paving appears to be on a slightly different alignment from that of the

Figure 4: Tiled paving surface below the current paved Durbar Square, in Trench 1A.

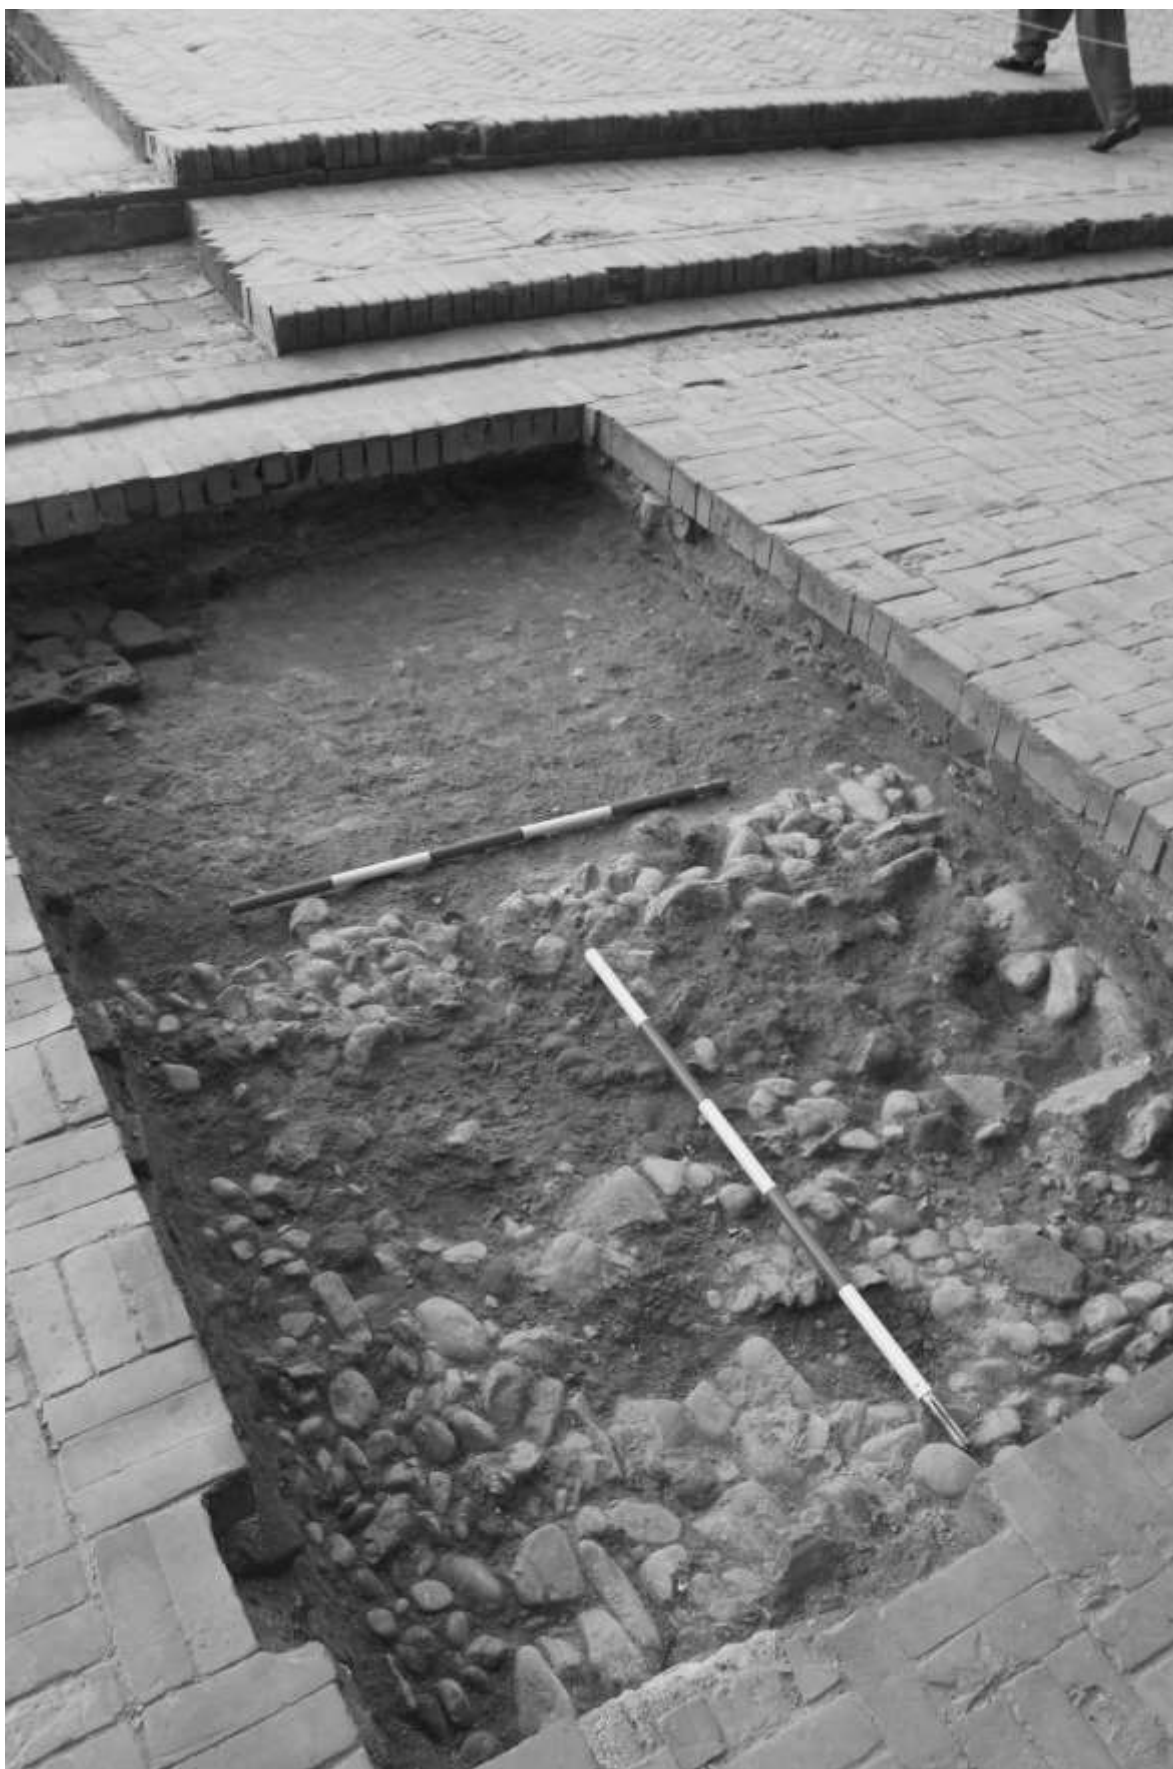
Below this material was a surface of stone cobbles to the east of the trench (Figure 6). These cobbles may represent an earlier episode of surfacing of the square or may have been related to an earlier structure. Also at this level were the remains of a brick wall stump,

Figure 6: Stone cobbled surface below current paving of the Durbar Square, looking North West in Trench 1B

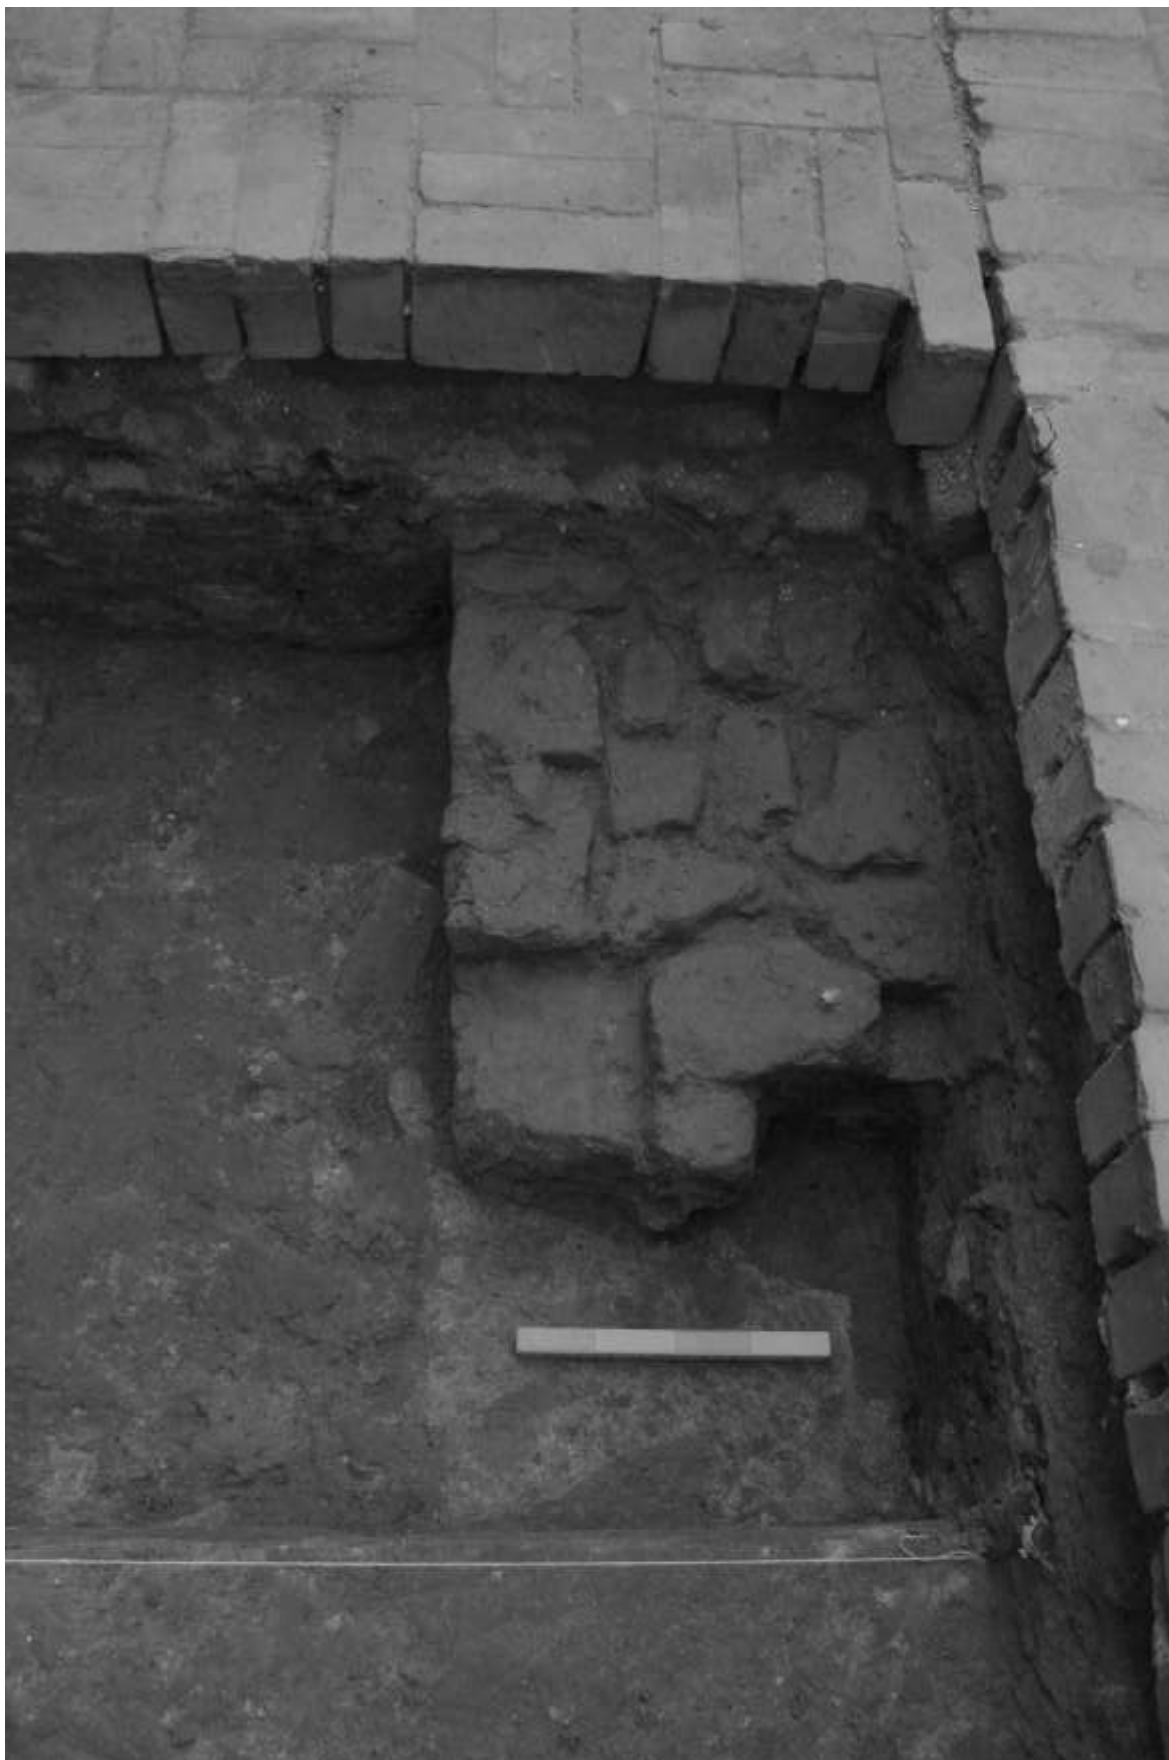
which survived to two courses (Figure 7). These features were cut by modern pipelines, running north-south in line with the current thoroughfare through the Durbar Square. As these features did not cut-through the two levels of brick paving and were sealed by these surfaces, it would appear that these interventions had occurred before the current paving of the Durbar square was laid. The stone cobbled surface and brick wall stump clearly illustrate the presence of archaeological features and surfaces below the current level of brick paving in the Durbar Square. The pipelines that cut through these features also highlight the need for future archaeological assessments and archaeological watching briefs before any intrusive digging across Patan's Durbar Square.

Figure 7: Brick wall, looking south west, Trench 1B.

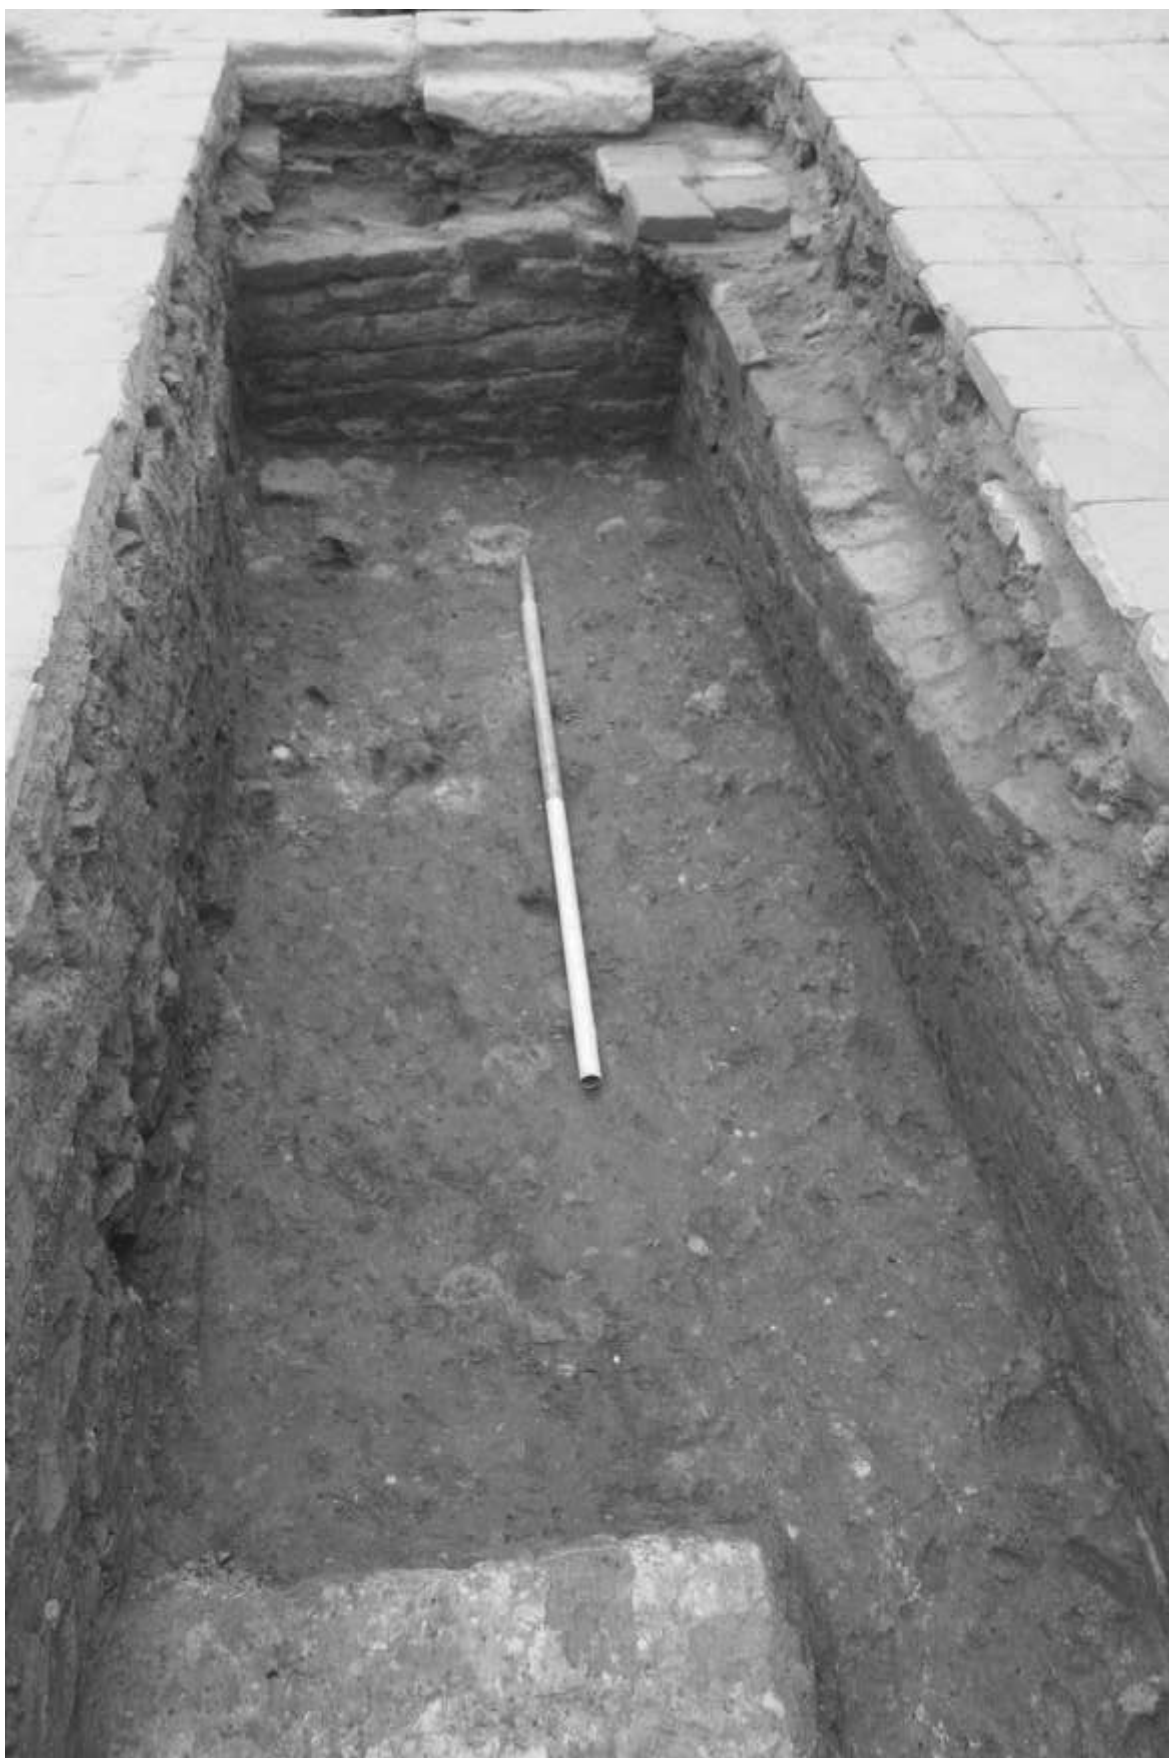
Once this setting was removed, along with a shallow levelling deposit that contained brickbat, broken tile and pottery, two walls were uncovered. Forming a return, one of these walls ran north-south at the eastern edge of the trench to the west of the current exposed facing of the tiled Temple platform, which formed a baulk between Trenches 1A and 1C. However, although this wall in all probability followed the same alignment as the current facing, it might be an earlier phasing of walling, though further excavation is required to ascertain this relationship. In the south-east corner of the trench was the wall return, which ran on a slight south-west to north-east alignment, different to that of the Char Narayan Temple (Figure 8). However, though the alignment was slightly different, the wall did appear to run towards the south-east corner of the foundation platform, which further to the north formed the east-facing section of Trench 1C.

Figure 8: Wall alignment below current paving in Trench 1C, looking east.

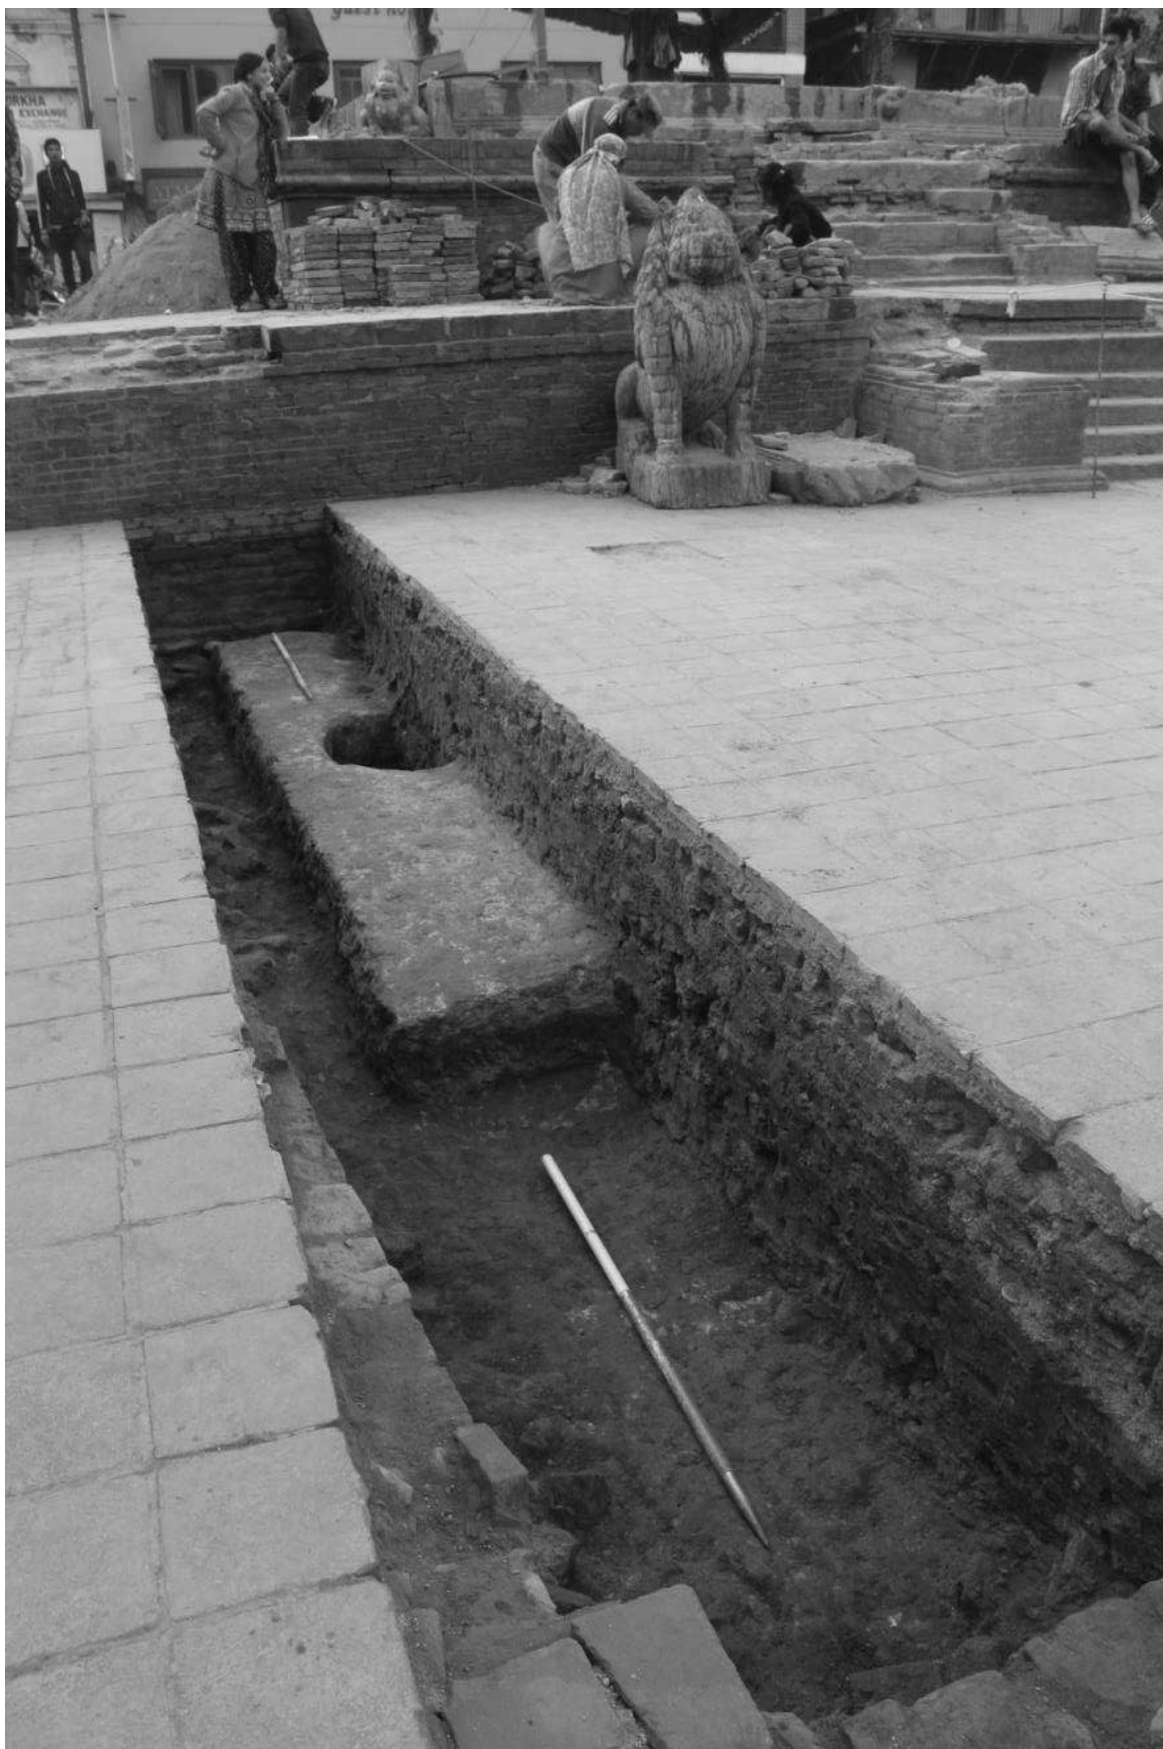
of the current Char Narayan Temple (Figure 9). This clay platform suggests that the site of the Char Narayan Temple had hosted non-durable monumental architecture prior to the construction of the current brick, stone and timber Temple, or that earlier configurations of the Temple incorporated such architecture before the square was paved with tiled or brick surfaces. Several phases of clay platforms were removed on this same alignment and these were cut by a large semi-circular feature that ran underneath the south-facing section. This cut, with its fairly firm silty clay fill, which included brickbats and ceramics, was evidence of a large posthole cut. Most likely for a large timber architectural element, this feature and associated clay platforms may relate to an earlier Temple footprint, constructed from non-durable materials. There is also a possibility that it might relate to a non-durable architectural element associated with the current Temple, perhaps relating to a pavilion or more temporary shelter located to the east.

Figure 9: Earlier clay platform with large posthole, in Trench 1C, looking west.

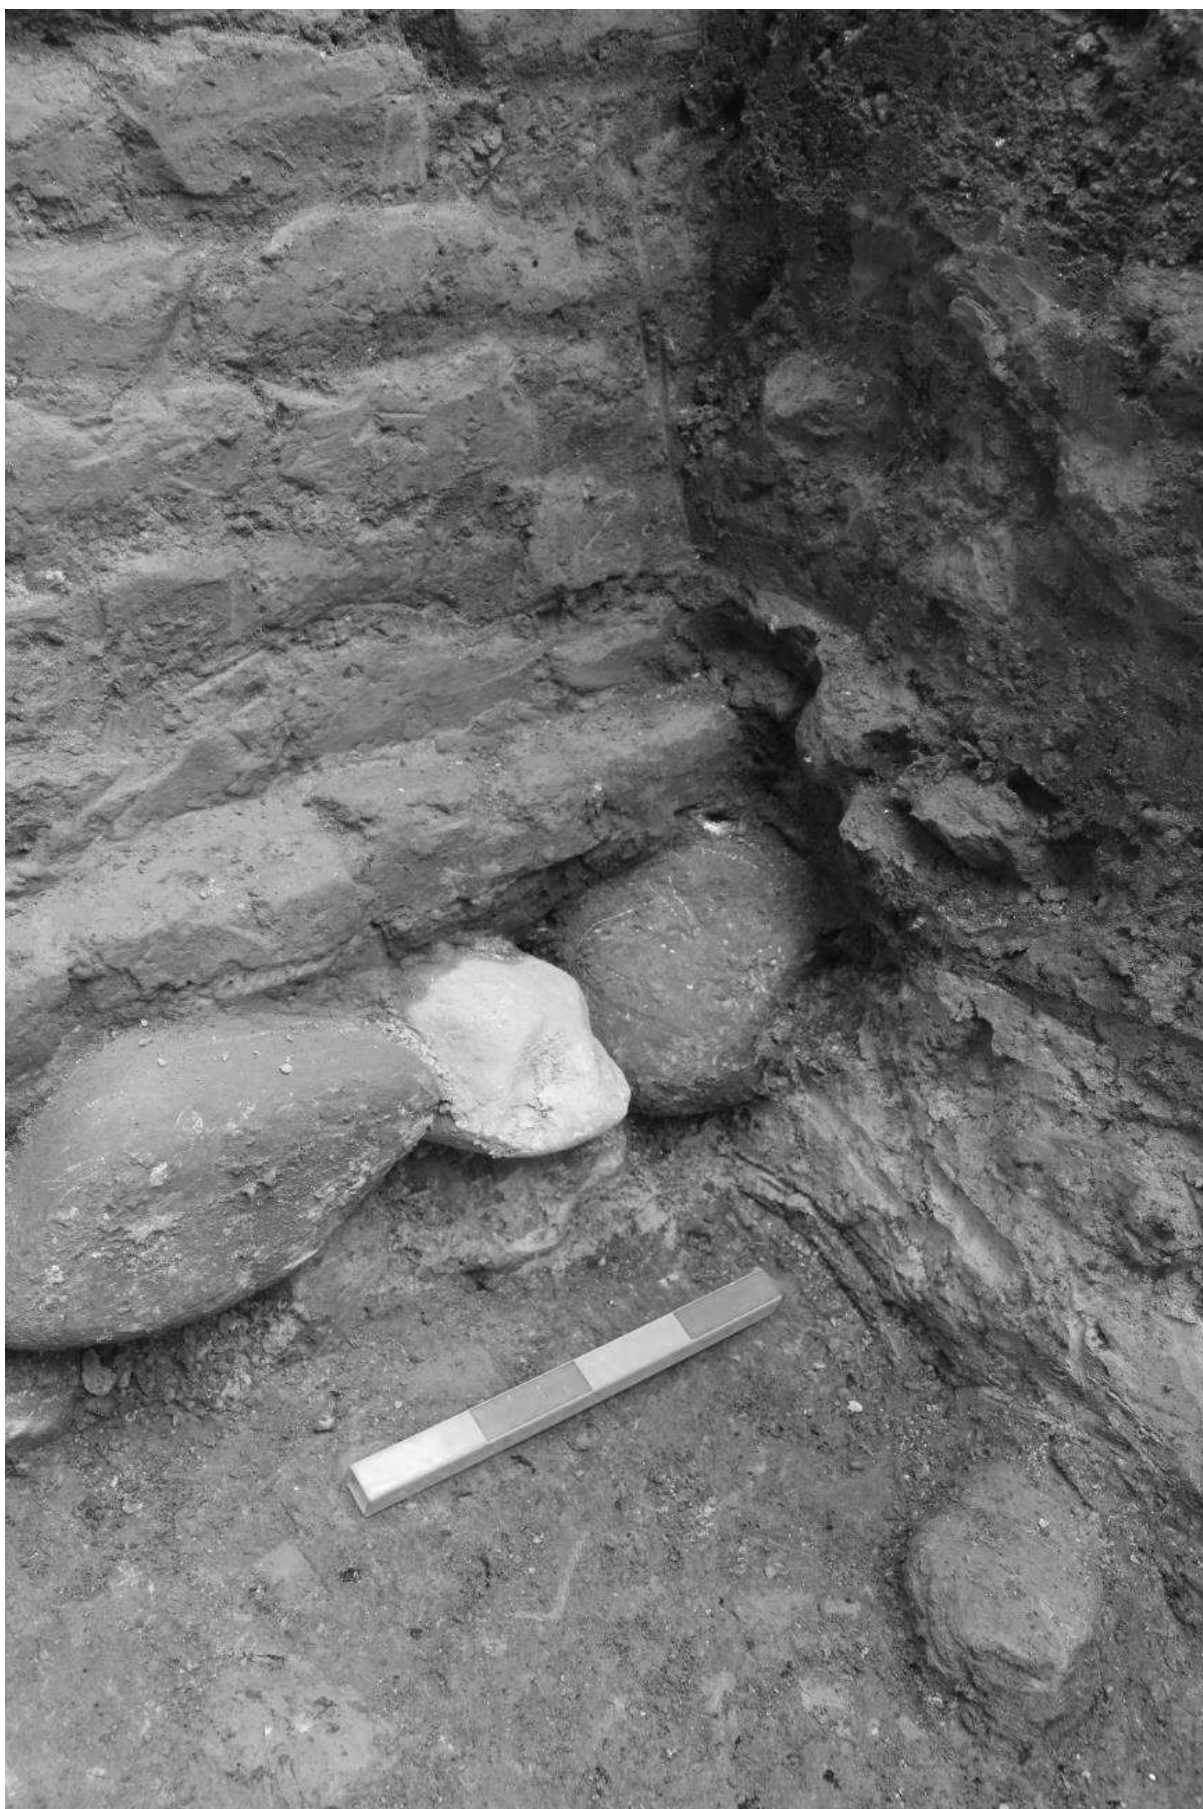
However, before we are able to process scientific dating samples, we believe that it is more likely to represent an earlier phasing of construction as the brick wall of the Char Narayan Temple in the west-facing section cuts through these platforms, suggesting that the current Temple is later in date (Figure 10). The foundation wall of the current Temple included a course of tiles, forming a conservation line below the currently visible conserved and repointed bricks. Below this course of tiles were seven courses of original brick, which then sat on top of three visible irregular courses of stone cobbles (Figure 11). The slot that this wall sat within appeared to be cut through the earlier clay platforms, suggesting the placement of stone cobbles and the brick courses were a later intervention at the site.

Figure 10: Stone cobble foundations, cutting through clay platform, in Trench 1C.

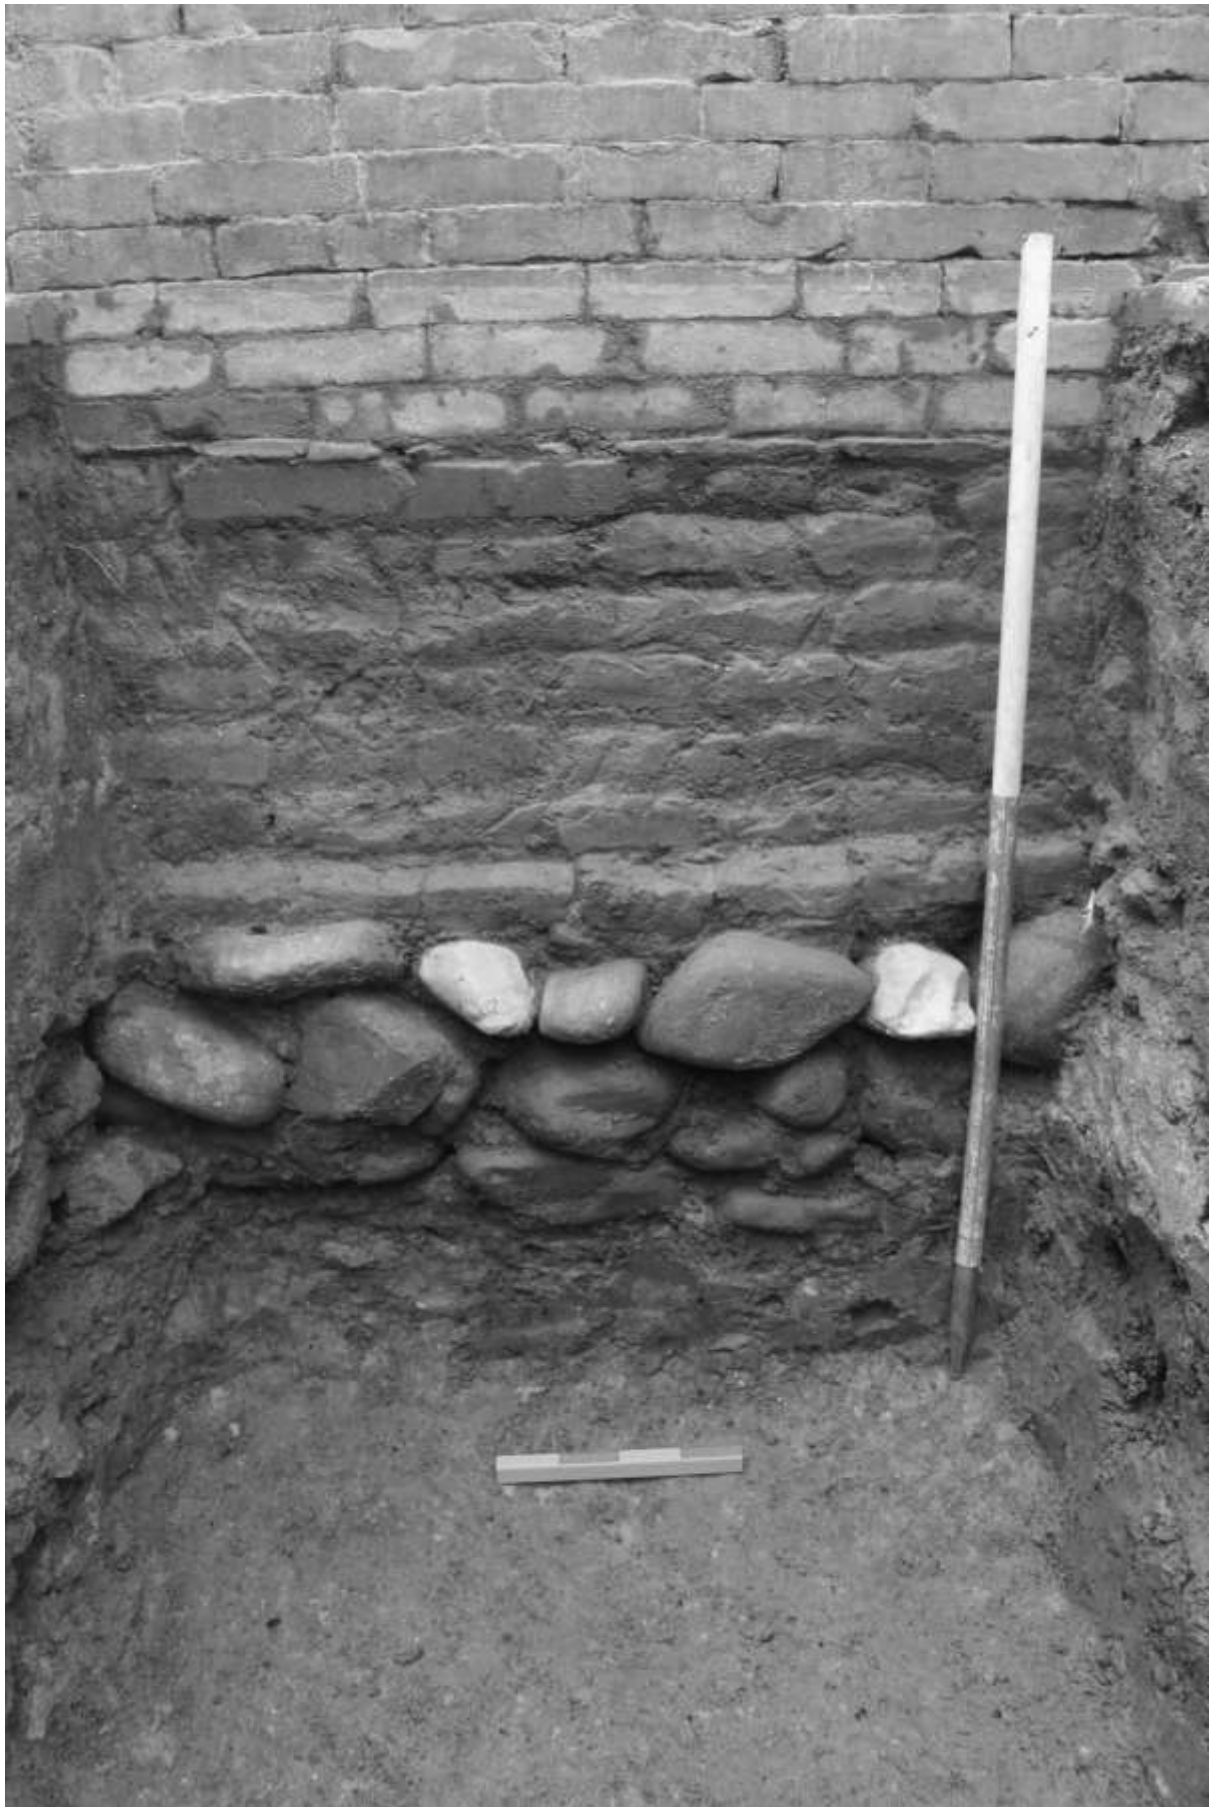
Figure 11: Stone cobble and brick foundations of Char Narayan Temple in Trench 1C.

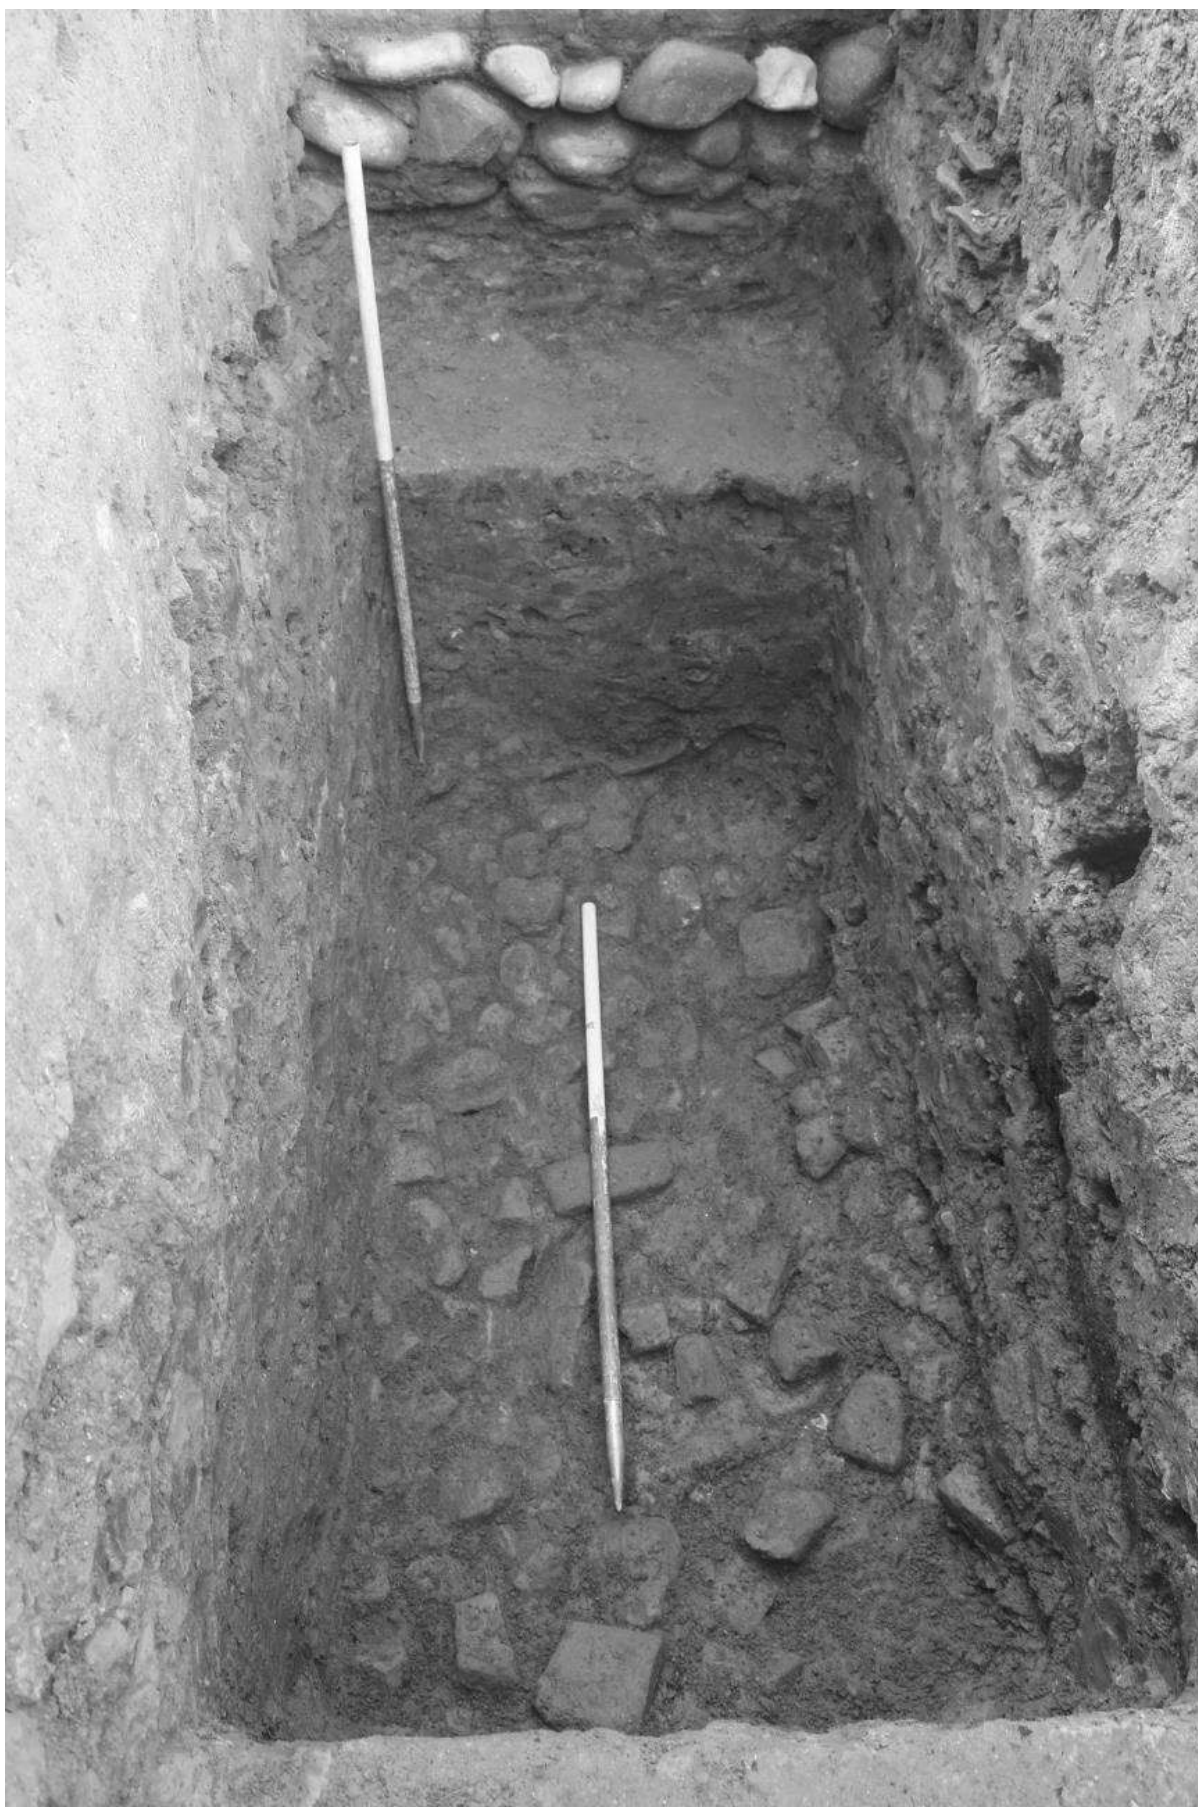
Figure 12: Brickbat surface in Trench 1C, looking west.

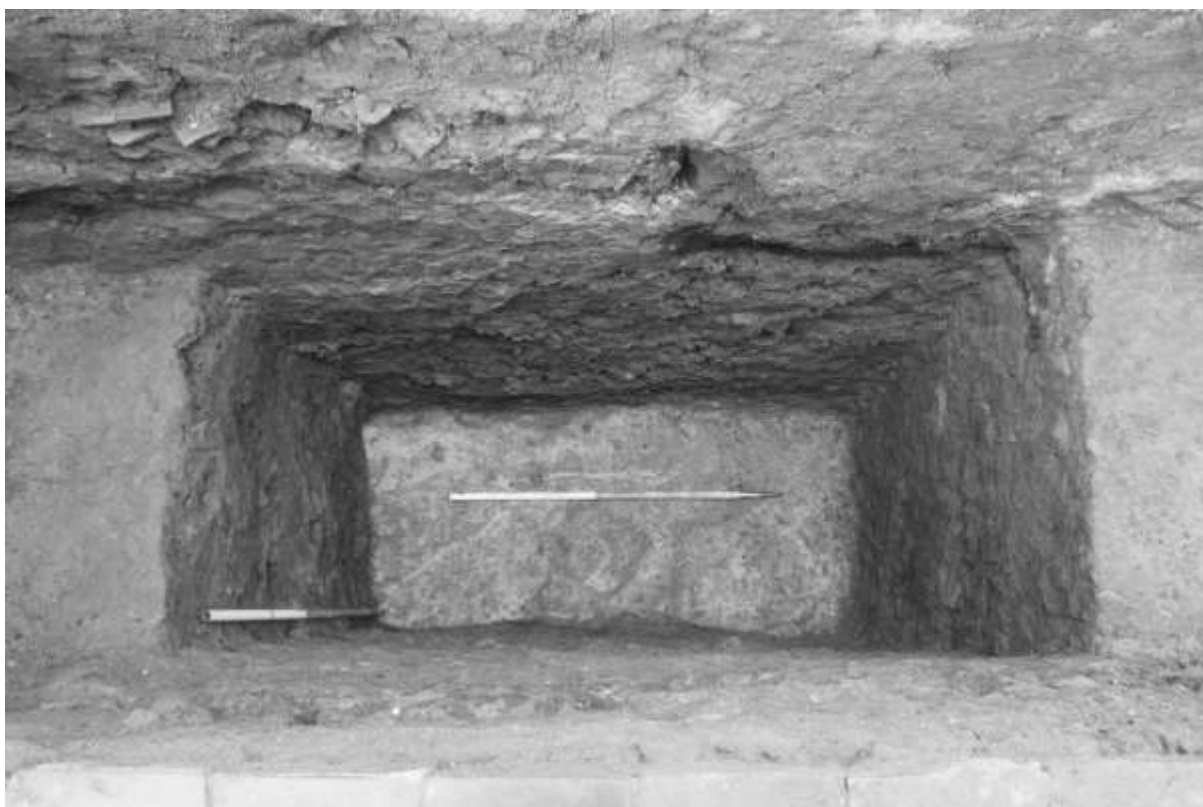
The clay platforms sat on a surface that comprised small brickbat pieces. Once this was exposed in the entirety of the trench, a small sondage, measuring two metres east-west by one metre north-south was opened to gain a deep sequence. This was opened 0.5 metres from the east facing section. Several deposits were removed, with a concentration of brickbats potentially representing an earlier surface at a depth of c. 0.5 metres from the top of this sondage (Figure 12). Below this brickbat spread was a greyish silty clay deposit, which may have related to the deposit found at the base of the sequence in Trench 1A. This overlaid a very thin deposit of dark charcoal rich silt, which itself covered a very compact brown material containing small brickbat fragments. Forming a rectangular shape in plan, this material may represent an early floor surface. Once removed, a yellow sterile clay, lacking any indication of cultural material, and potentially representing the natural soil, was reached at a depth of 2.50 metres from the top of the current paved surface of this platform within the Durbar Square (Figure 13).

Figure 13: Possible natural at the base of the sequence of Trench 1C, looking north.

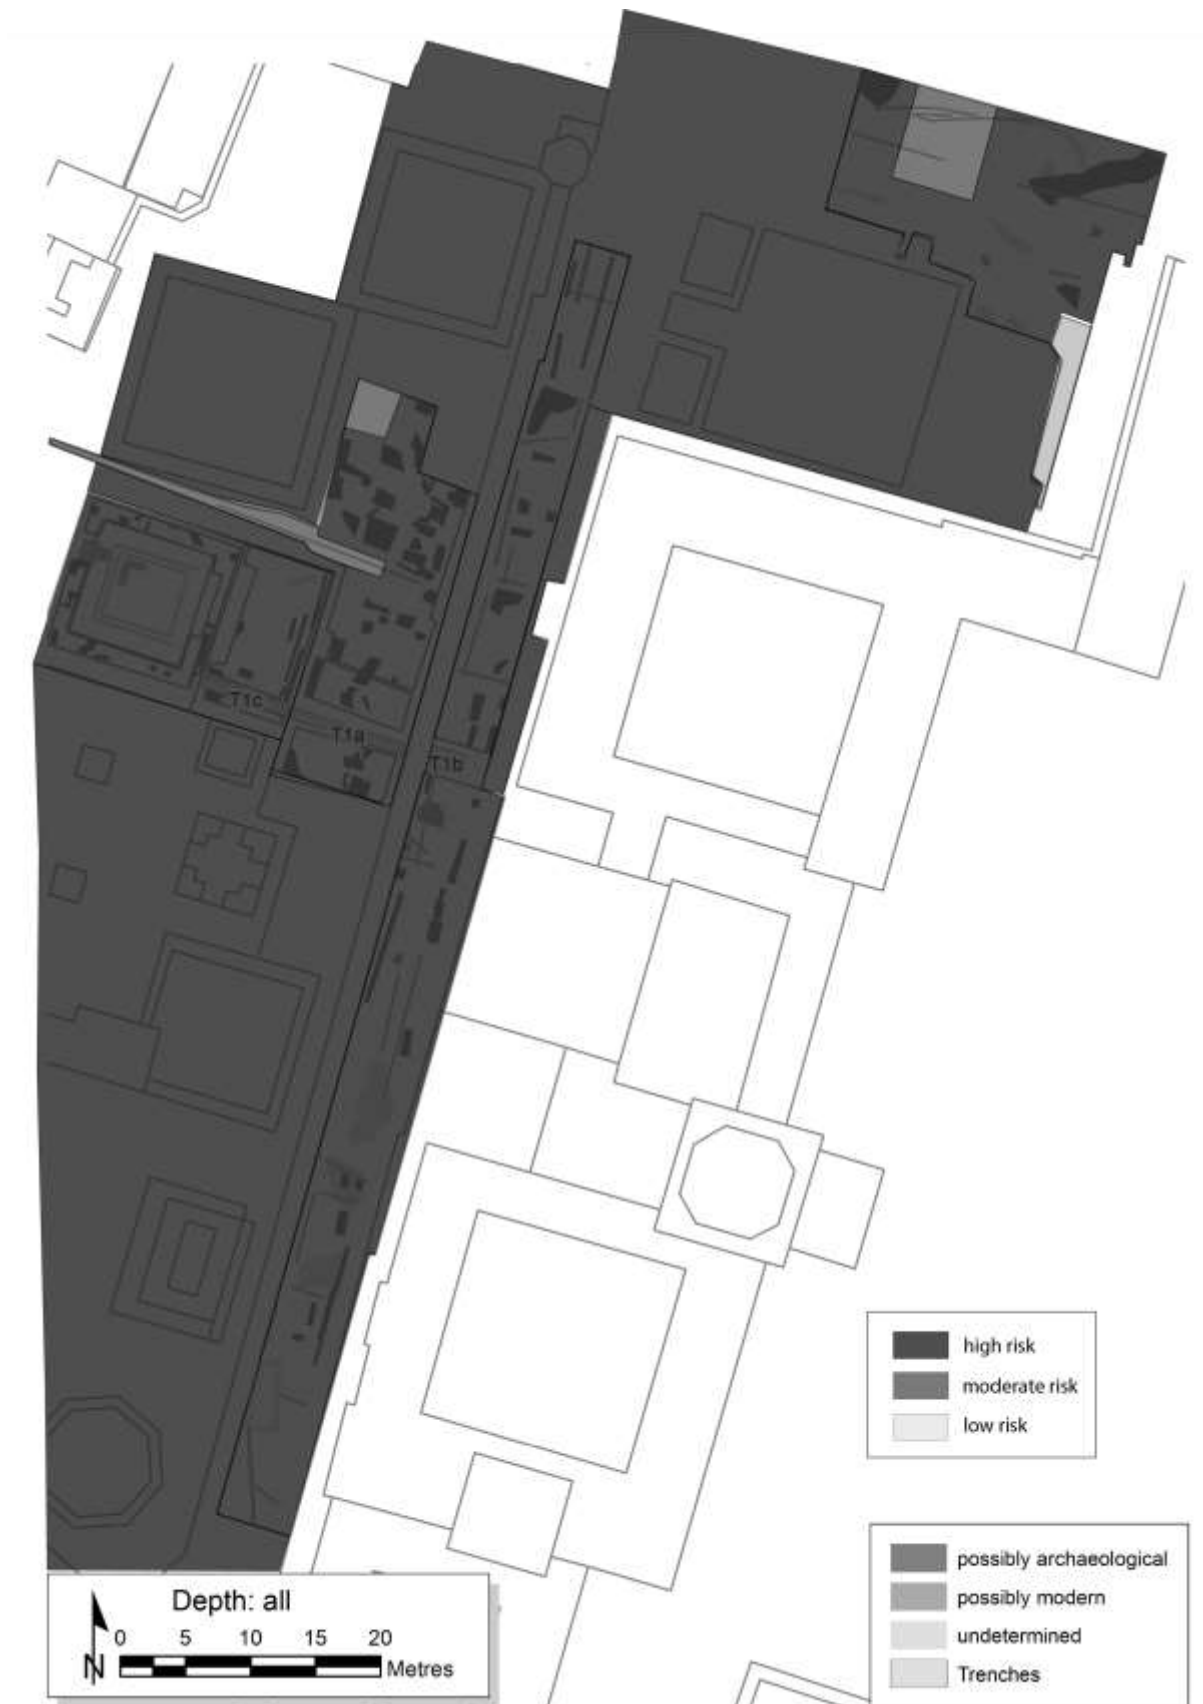
The archaeological investigations at the Char Narayan Temple and within Patan's Durbar Square have illustrated the extent of subsurface heritage at this World Heritage site. The GPR survey has highlighted areas of potential archaeological features below the current square and excavations have revealed the character of some of these signatures. What is clear is that the Durbar Square was not always an open space but has developed over time, only in the last few centuries reaching its current configuration of standing monuments. One of the key features identified through GPR survey and excavation were pipelines running through the Durbar Square, which we have clearly demonstrated have cut through archaeological stratigraphy and earlier phases of human activity. Such interventions are therefore a concern as the laying of any infrastructure has the potential to damage and destroy subsurface heritage of this site of Outstanding Universal Value.

Figure 17: Provisional Archaeological Risk Map for Patan's Durbar Square.

The damage caused by the earthquakes will require reconstruction and also the repair and laying of amenities in Patan and whilst we do not recommend the suspension of the laying services and reconstruction we do advocate the mobilisation of rescue archaeology teams to undertake rescue excavations in advance of interventions (Coningham et al. 2016c). The Archaeological Risk Map for Patan will provide information for site managers and stakeholders as to the risks posed to subsurface heritage and help guide future development (Figure 17). Indeed, from our observations and investigations, we feel there needs to be a heightened awareness that the cultural heritage of Patan is not restricted to its standing remains and architectural treasures but that it should extend also to the foundations of these monuments and to preceding phases of cultural development, which are found below the current ground level. The Archaeological Risk Maps and our
